Request for Conditional Closure

Site: Open Pits Site, also known as Two-Party Agreement (TPA) Site 6/National Oceanic and Atmospheric Administration (NOAA) Site 6. The site will be referred to as the Open Pits Site herein.

Request for Conditional Closure
Open Pits Site, TPA Site 6/NOAA Site 6
St. George Island, Alaska

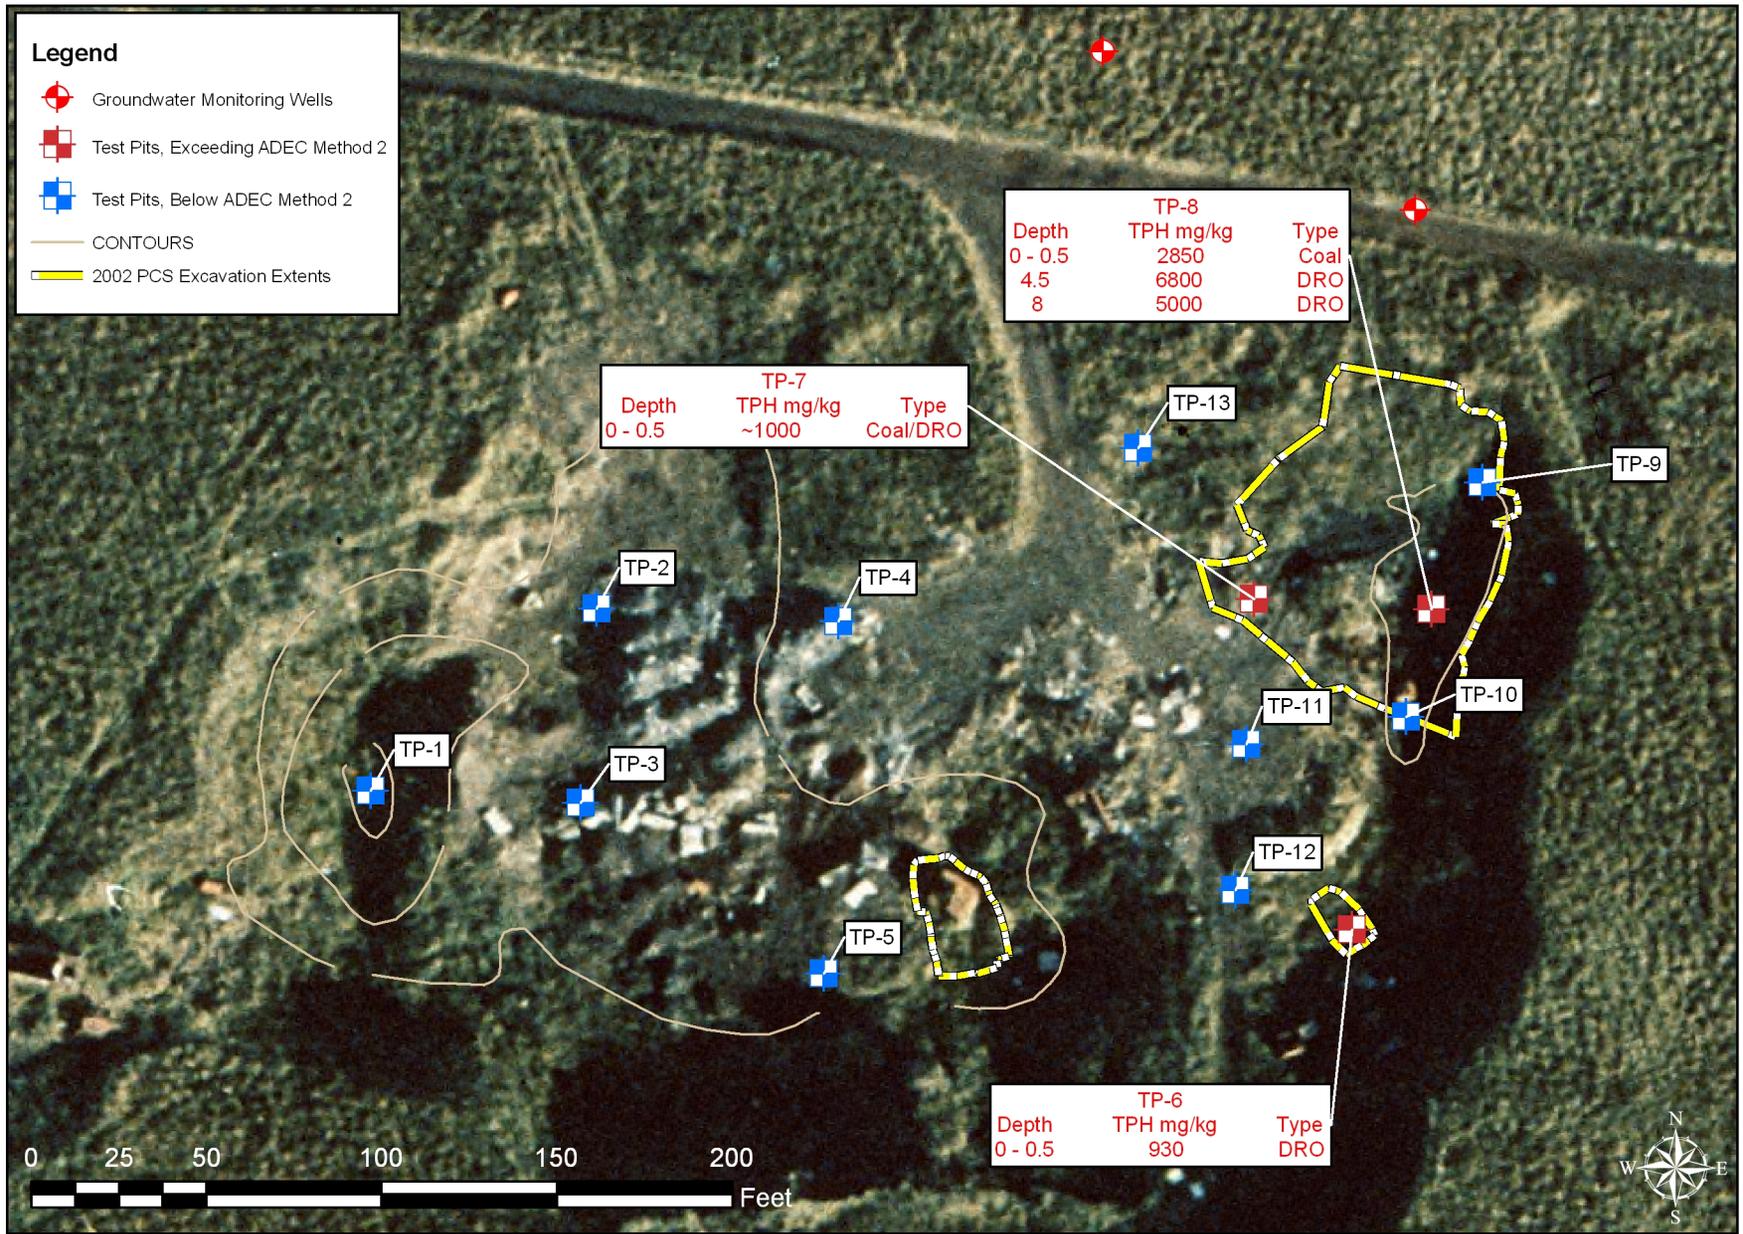
excavated in the investigation (Figure 3). Thirty-nine soil samples were submitted to a field laboratory for petroleum hydrocarbon analysis; 12 for PCB and pesticide analysis; and six for benzene, toluene, ethylbenzene, and total xylenes (BTEX) analysis. One of the samples was found to have gasoline range organics (GRO) at a concentration of 80 milligrams per kilogram (mg/kg), and diesel range organics (DRO) were detected in 11 of the samples at up to 6,800 mg/kg. Residual range organics were detected in eight of the samples at up to 2,100 mg/kg. BTEX, PCBs, pesticides, and metals were eliminated as contaminants of concern. Hart Crowser recommended excavation and removal of 620 cubic yards (yd³) of contaminated soil.

NOAA selected Method Two to determine cleanup levels for DRO, RRO, and BTEX at the Open Pits Site. Figure 3 shows the locations of soil samples and results that exceeded the Method Two cleanup levels prior to cleanup actions.

**Hart Crowser 1996 Site Investigation
Open Pits Site
TPA Site 6/NOAA Site 6
St. George Island, Alaska**

Polarconsult conducted an excavation of petroleum contaminated soil (PCS) at three locations at the Open Pite Site in 2002 (Polarconsult 2004), following the approved corrective action plan (Polarconsult 2002) (Figure 3). Although Hart Crowser had estimated in 1997 that only 620 cubic yards (yd³) of PCS remained on site, Polarconsult removed a total volume of 2,149 yd³ (Polarconsult 2004). An additional 361 yd³ of clean overburden was also excavated in the process, later used as clean fill. The cleanup actions at the three locations are discussed below.

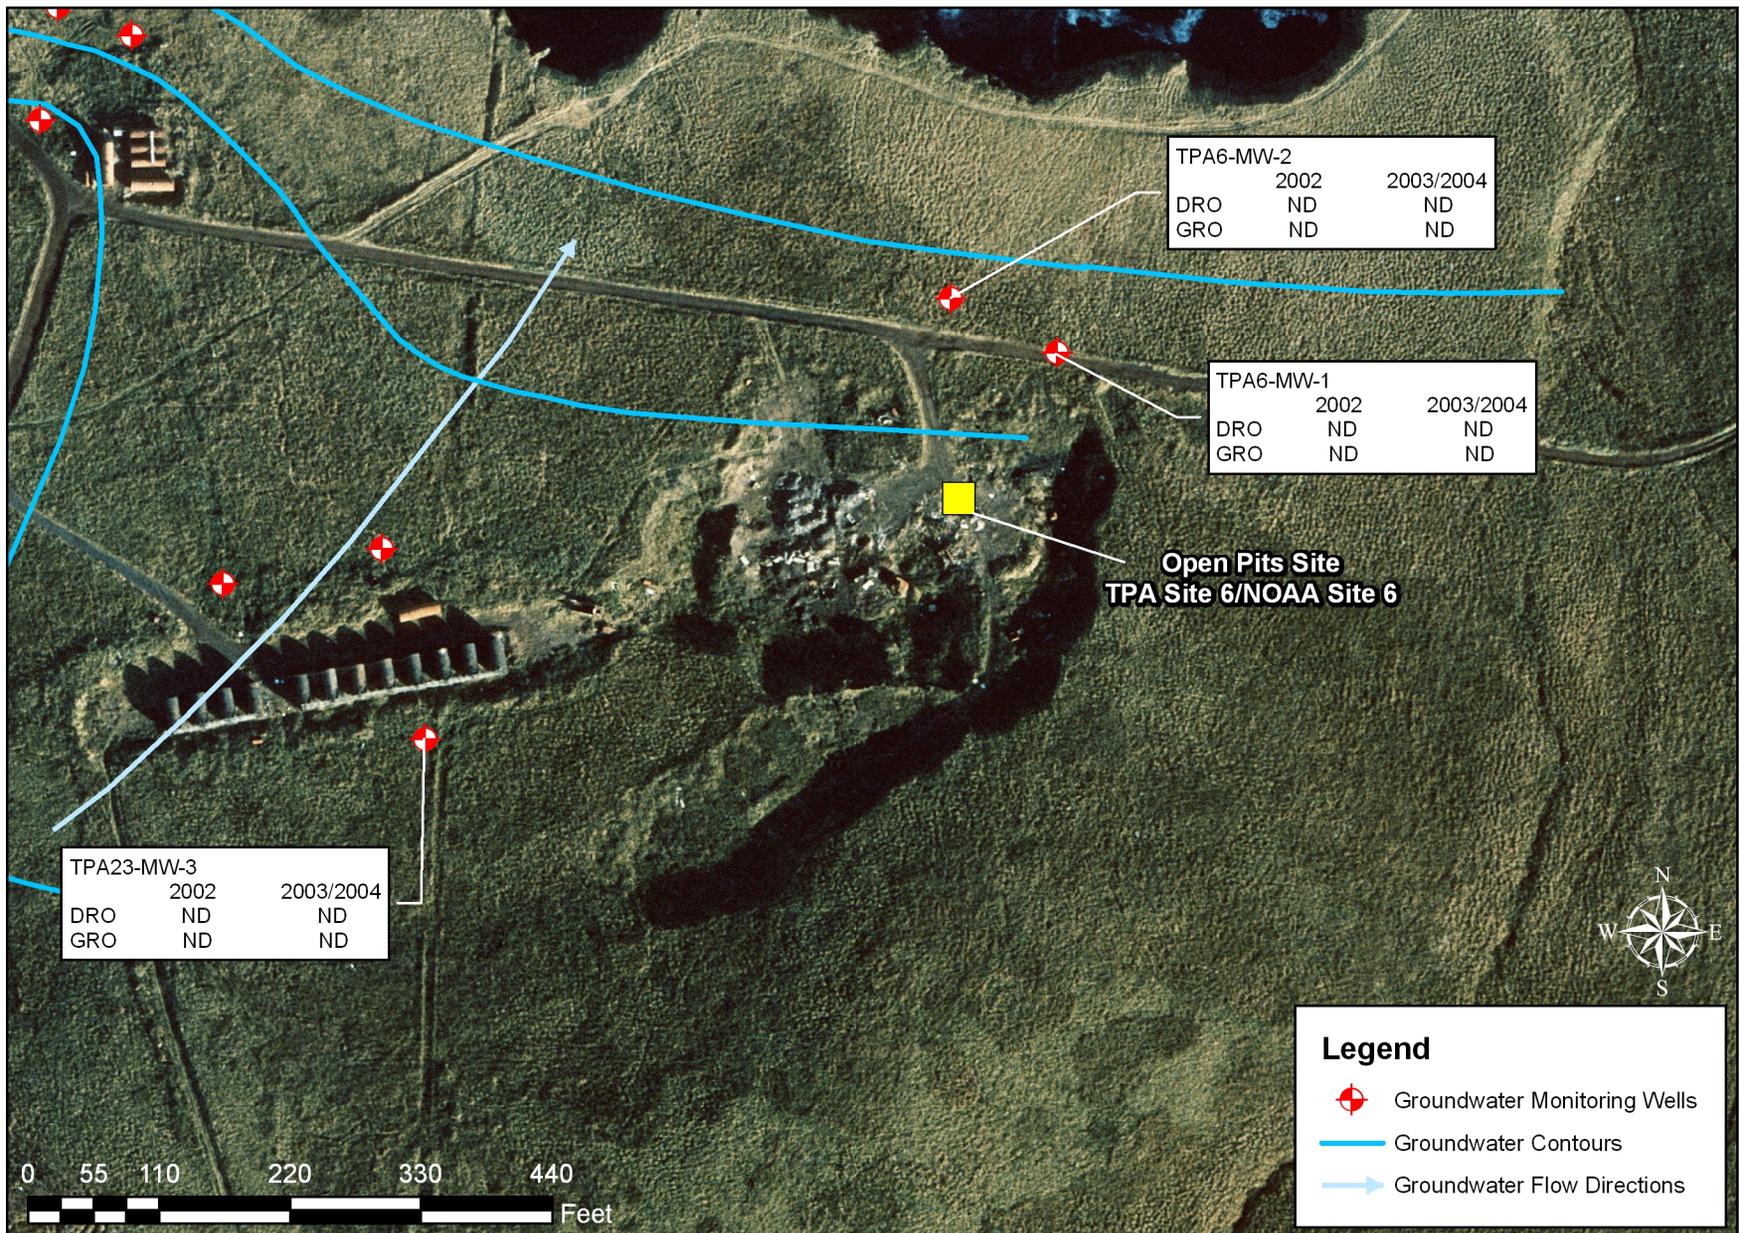
Tetra Tech Groundwater Monitoring, 2002, 2003, 2004: Groundwater monitoring for GRO, DRO, and volatile organic carbons was conducted at the Open Pits Site in 2002, 2003 and 2004 at two monitoring wells as shown in Figure 4 (Tetra Tech 2005). A third monitoring well at the Inactive/Abandoned Diesel Tank Farm, TPA Site 23, is shown on Figure 4 to provide groundwater results from a well upgradient of the Open Pits Site. No contaminants have been detected in these wells with analyses that achieved detection limits below the 18 AAC 75.345 Table C cleanup levels.

**Groundwater Sampling Results for
Petroleum Hydrocarbons
Open Pits Site
TPA Site 6/NOAA Site 6
St. George Island, Alaska**

Note: Results in µg/L (Microgram per liter); ND (analyte was analyzed for but was not detected); Results presented represent the maximum detection for the sampling cycle. Where no results are listed, DRO, GRO & BTEX were not detected.

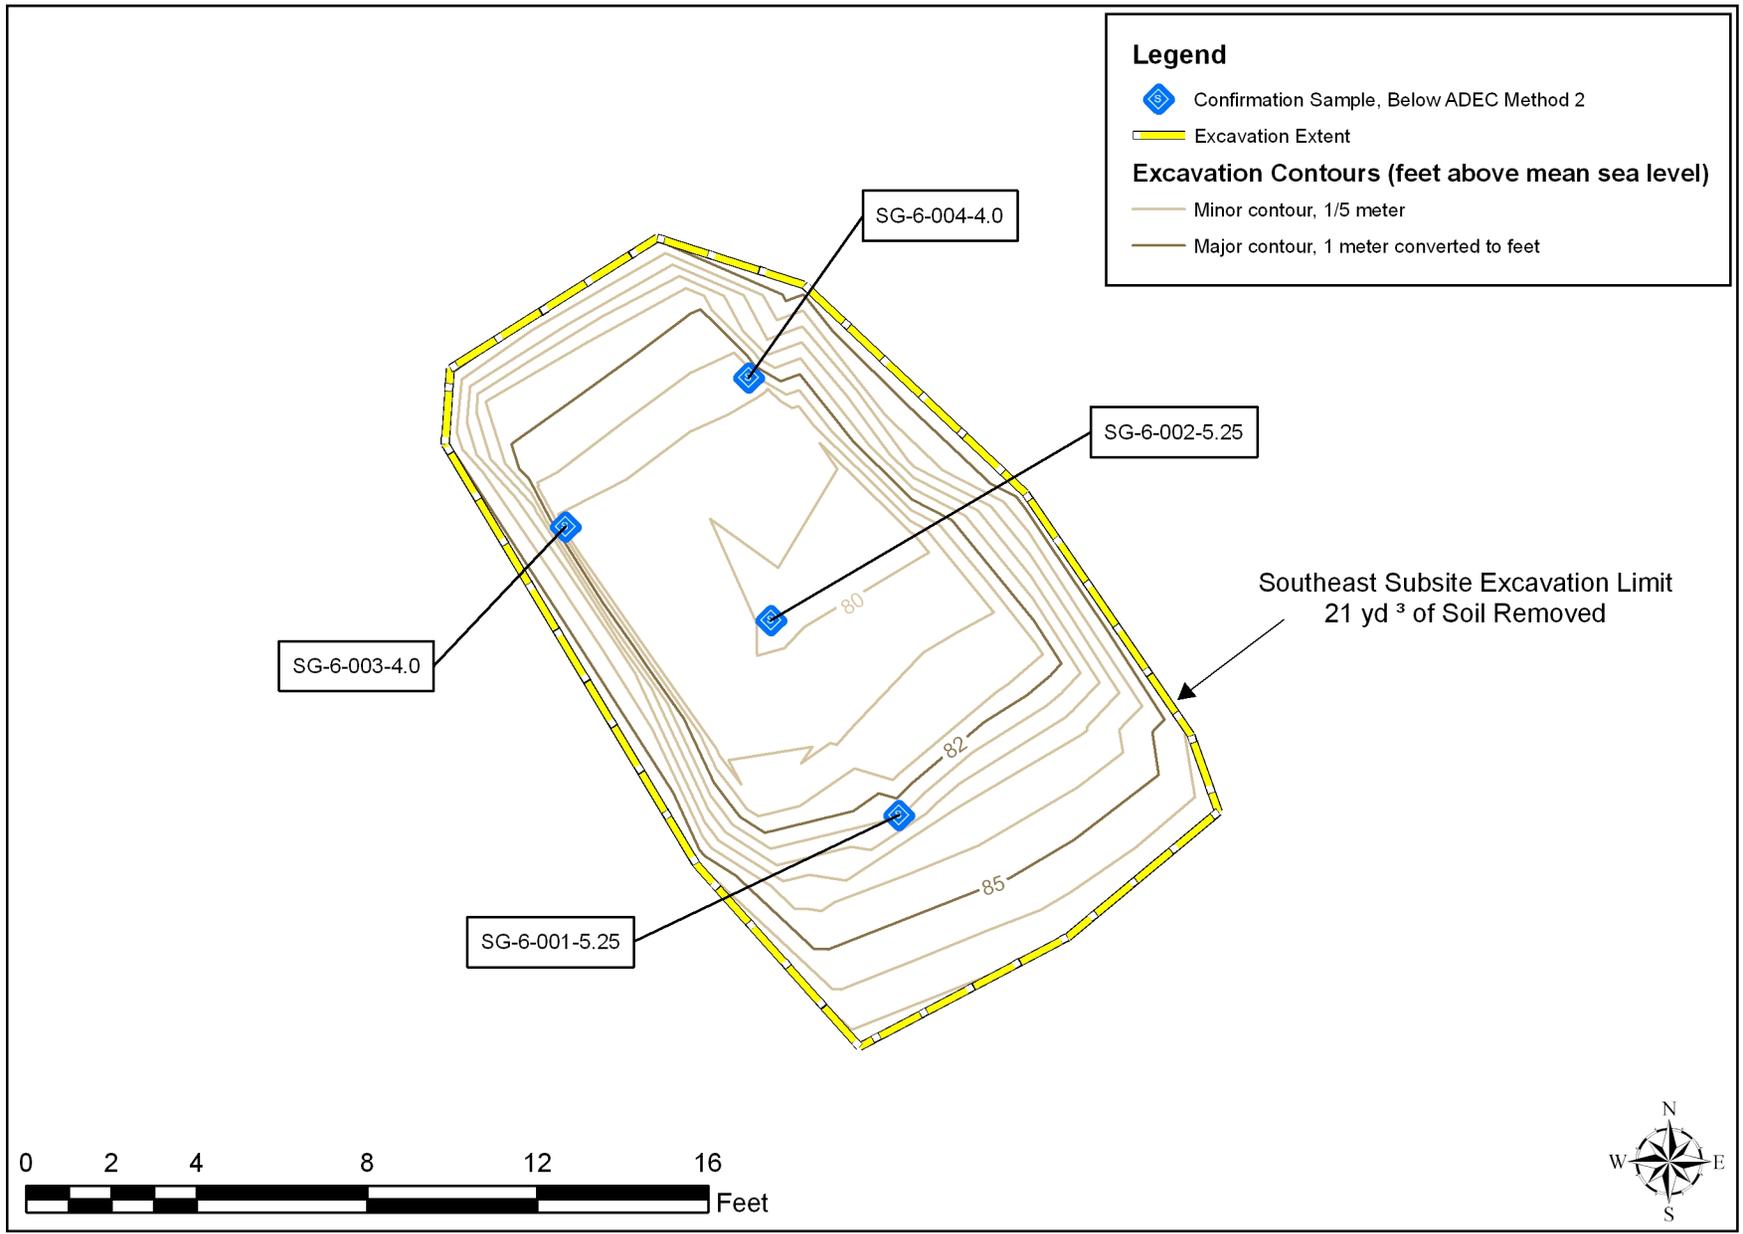
Figure
5

Southeast Subsite: Polarconsult's excavation in the vicinity of TP-6 identified visibly contaminated soil exhibiting a strong diesel odor (Figure 5). Polarconsult evaluated soil on-site with a photoionization detector (PID) in an effort to estimate if the soil exceeded the site cleanup levels. Recovery of contaminated soil continued downward and outward until soil exceeding the cleanup levels was no longer evident, as determined by field screening. A total volume of 22 yd³ of PCS was removed.

**Southeast Subsite
Open Pits Site
TPA Site 6/NOAA Site 6
St. Goerge Island, Alaska**

Following the corrective action plan (CAP), Polarconsult backfilled the three Open Pits Site subsites in late 2002, to the original contours that existed at the beginning of the project (Polarconsult 2004). The excavations were partially backfilled with 361 yd³ of clean overburden that had been removed from the excavations, analyzed, and shown not to exceed the cleanup levels for petroleum compounds. The remaining volume of the excavations was filled with treated PCS from NOAA's enhanced thermal conduction treatment system. Since completion of the project, no erosion of the backfilled sites has occurred and NOAA believes that the site restoration goals of the project have been met as defined in the CAP.

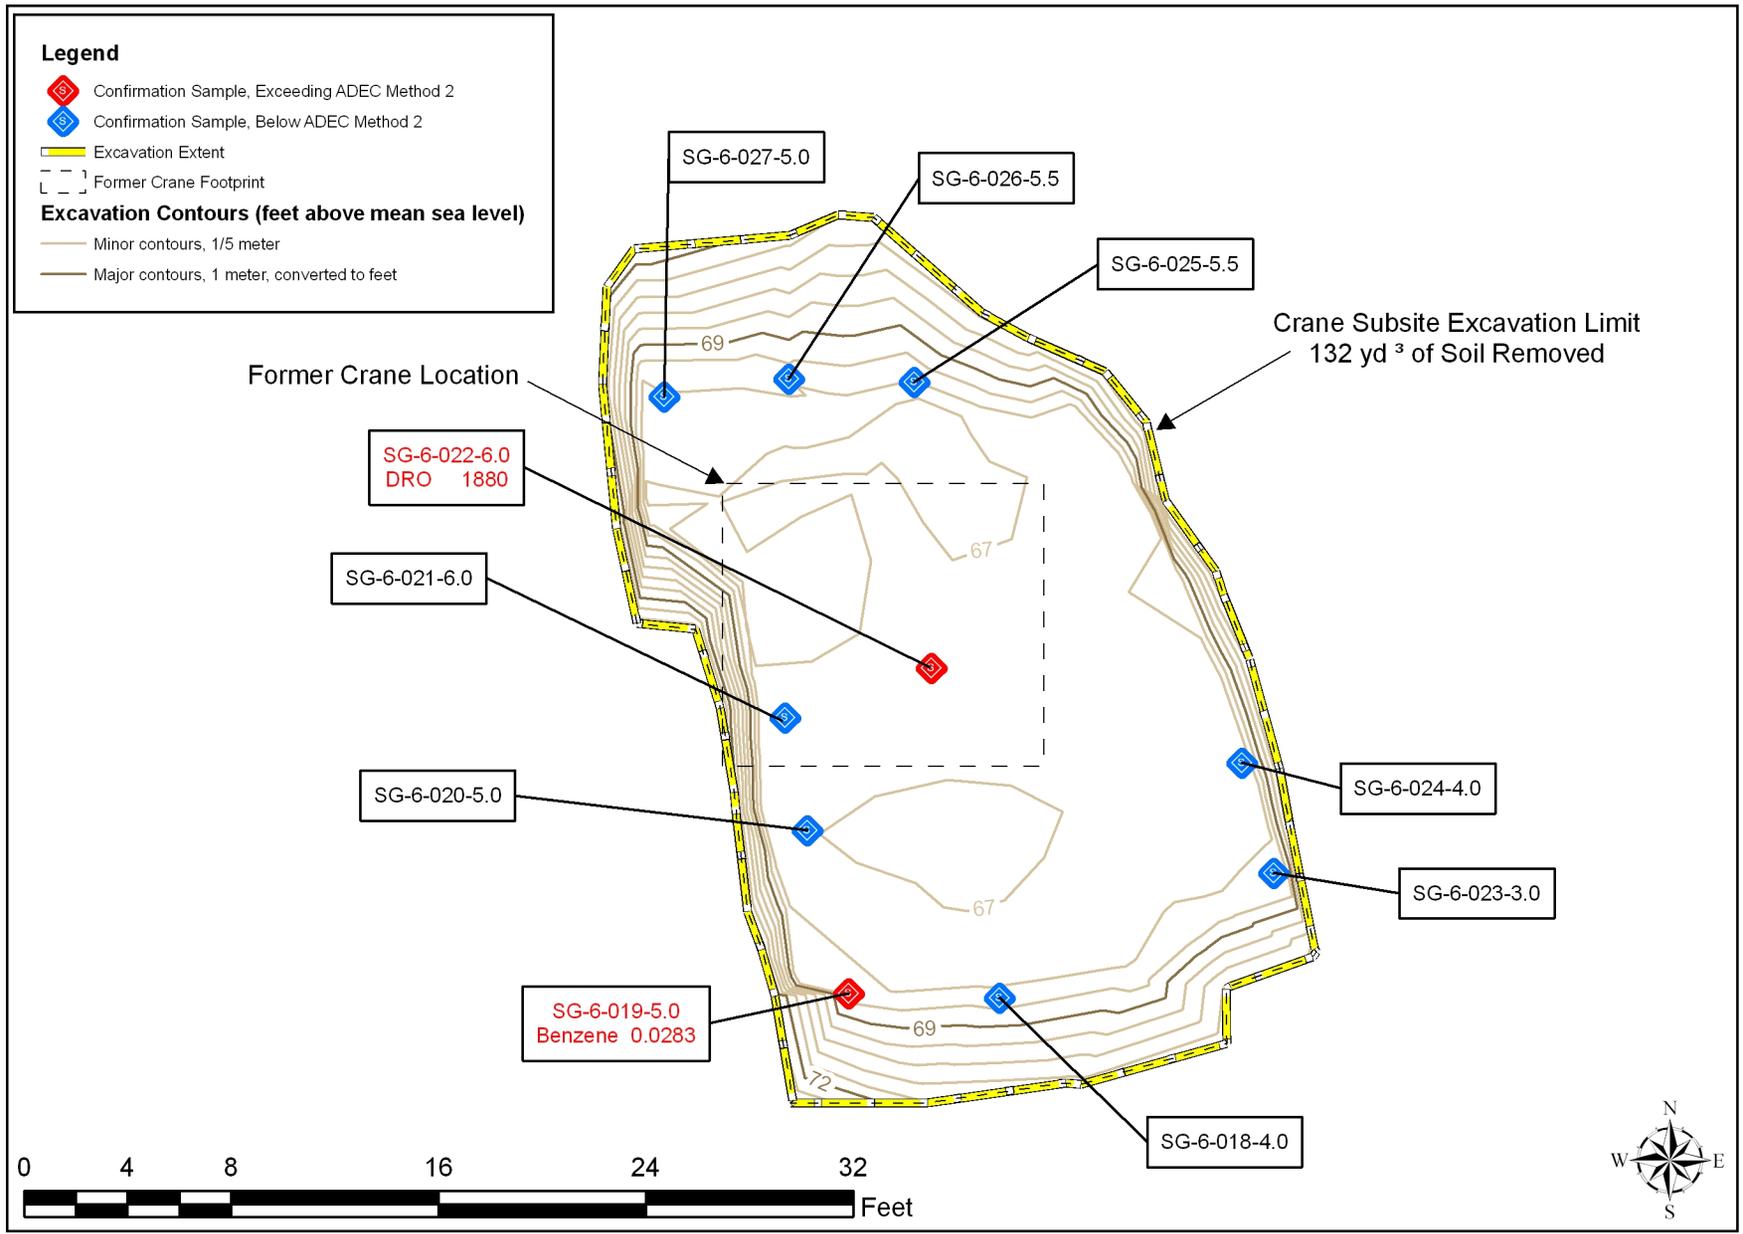
Figure
6

Crane Subsite: Polarconsults's excavation in the former area of the wrecked crane identified visibly contaminated soil with a strong diesel odor (Figure 6). Polarconsult continued recovery of PCS downward and outward until soil exceeding the cleanup levels was no longer evident, as determined by field screening, or until refusal occurred in competent red scoria at a depth of 5 feet bgs. Polarconsult observed that contamination continued vertically downward into the competent red scoria, but it could not be removed with the available equipment. After completing the removal of PCS, one confirmation sample exceeded the current Method Two cleanup level for Diesel, and one exceeded the current Method Two cleanup level for benzene, but this second sample did not exceed the 1991 Method Two benzene cleanup level used for the site. A total volume of 132 yd³ of contaminated soil was removed.

**Crane Subsite
Open Pits Site
TPA Site 6/NOAA Site 6
St. George Island, Alaska**

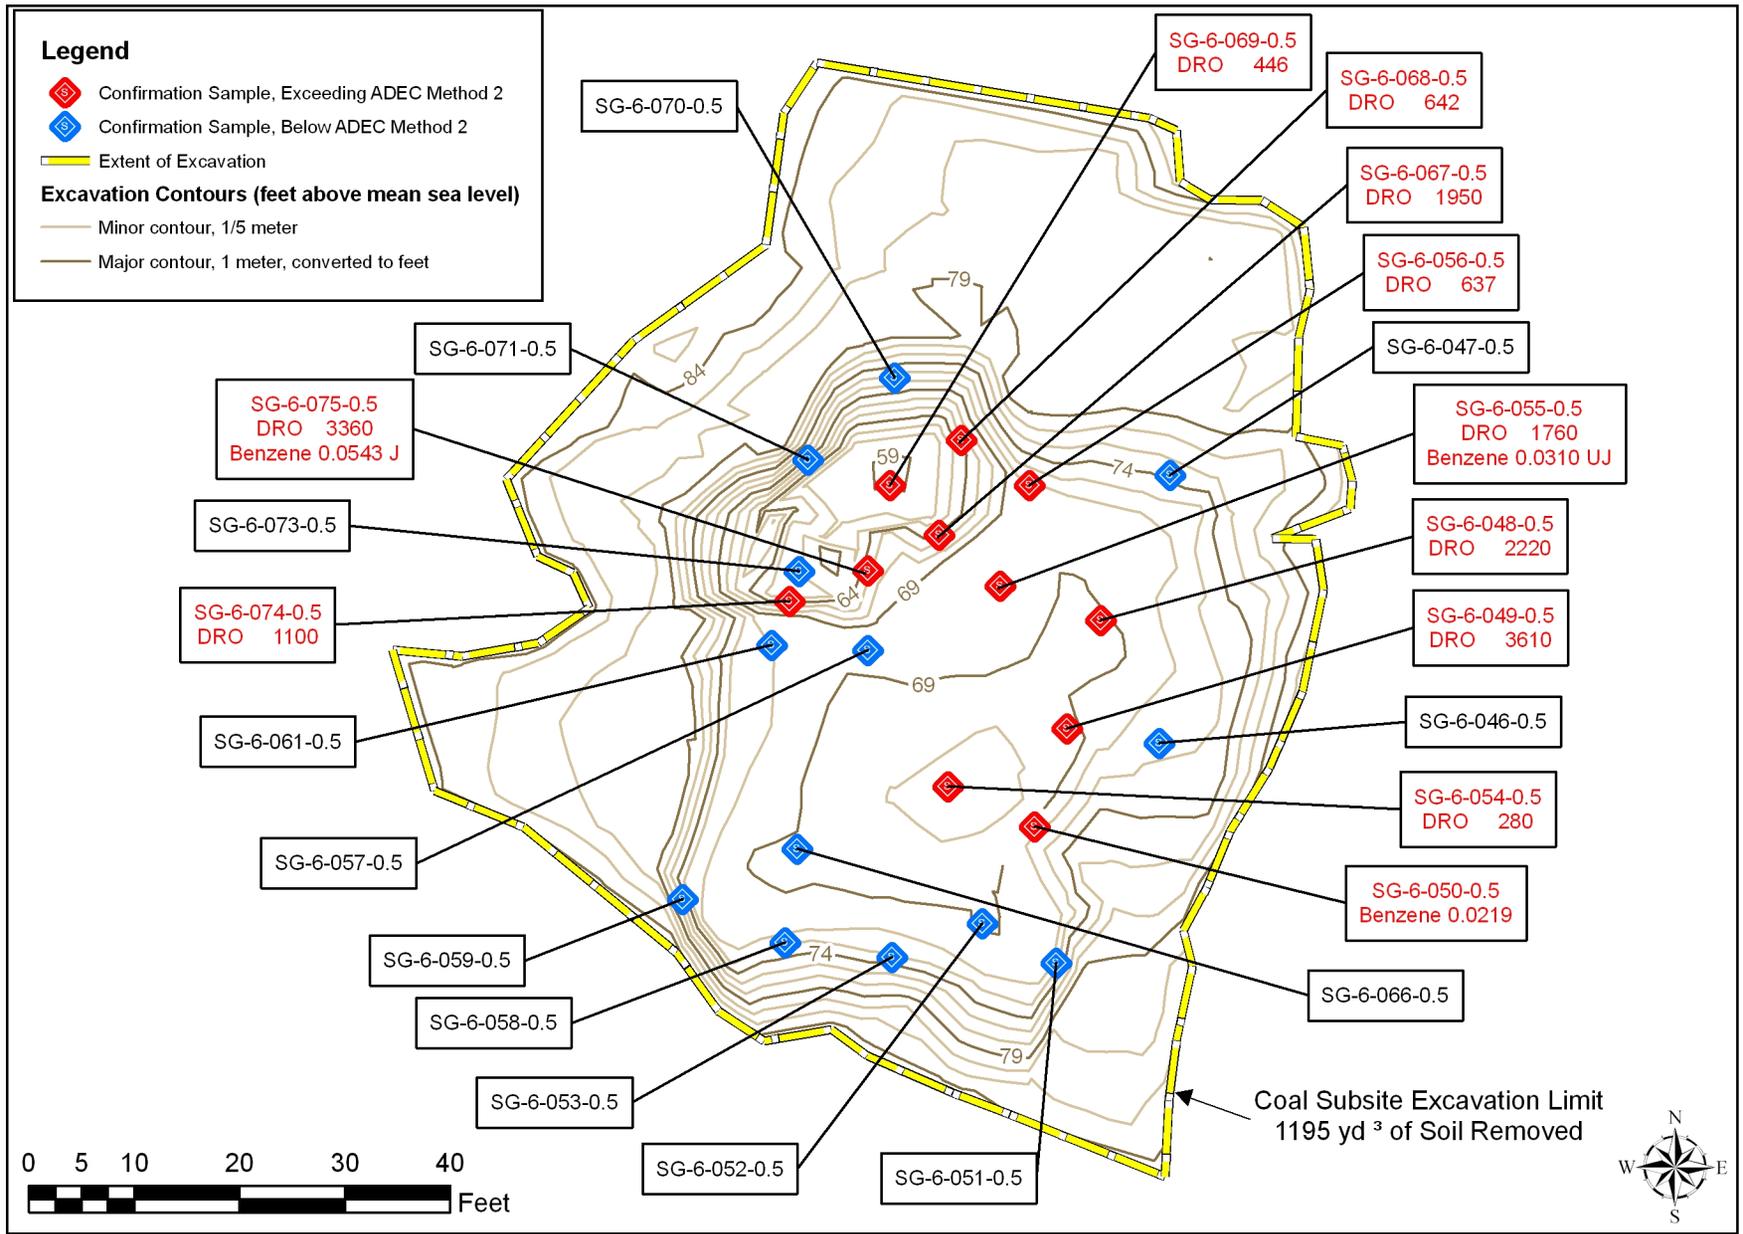
Figure
7

Coal Subsite: Polarconsult's initial recovery activities at the Coal Subsite involved the removal and segregation of loose anthracitic coal. The coal was transported to the Long-term PCS Stockpile and placed in a separate location from petroleum-contaminated soil. Polarconsult began excavating in the area around TP-8 suspected to be contaminated with petroleum as reported by Hart Crowser, 1997 (Figure 7). However, Polarconsult did not find elevated levels of contamination, and refusal was encountered at 2 feet bgs instead of 8 feet bgs as expected. These discrepancies probably resulted from difficulties in relocating the TP-8 site.

In an effort to find the known contaminated soil, Polarconsult excavated a new series of test pits. Polarconsult encountered visibly contaminated soil exhibiting a strong diesel odor northwest of the location originally believed to be TP-8. Observation indicated that the petroleum contamination continued downward into the competent basalt where it could not be removed with the available equipment. In the softer scoria, excavation was

continued beyond the planned stopping depth of 15 feet bgs in an effort to reach the deepest extent of contamination. Recovery of contaminated soil continued vertically and horizontally until soil exceeding the cleanup levels was no longer evident as determined by field screening, until refusal occurred, or until the excavation extended beyond the limit of the excavator at about 21 feet bgs (Figure 7). Refusal occurred in competent basalt at several locations. A total volume of 1,995 yd³ of contaminated soil was removed.

**Coal Subsite
Open Pits Site
TPA Site 6/NOAA Site 6
St. George Island, Alaska**
